East Mangochi
Rural Water Supply and Sanitation project
(EMRWSS)

PREMATURE FAILURE OF
HAND PUMPS

UNDERLYING CAUSE AND
RECOMMENDATIONS AIMED
AT REDUCING THE PROBLEM

A report to mark the 500th new
EMRWSS community borehole

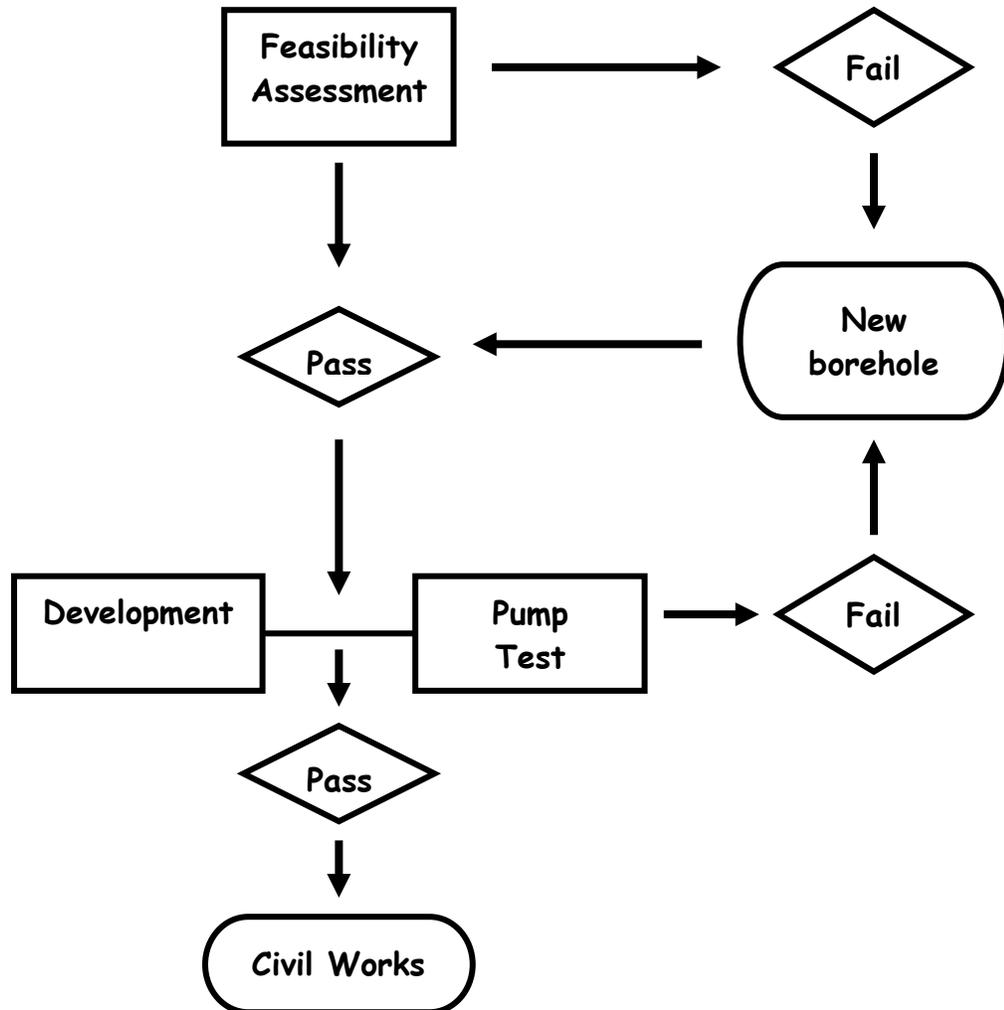
Figure 3.1 Flowchart: Stages of the rehabilitation process.

Any community applying for rehabilitation of an old hand pump had the borehole subjected to feasibility assessment, development and testing. If the borehole passed all

three stages then the old civil works was demolished and replaced with a new and more durable structure. Where the borehole failed (at any stage) then the community was granted a completely new borehole (sited and drilled). The stages are shown in Figure 3.1.

The feasibility assessment is a field exercise whereby the community is interviewed, borehole position and depth checked coupled with comparison with the available drilling documentation. The process concludes either with rejection and the siting of a new

borehole (pre-fail) or approval for physical rehabilitation. The borehole can again be rejected after physical rehabilitation (post-fail) on a number of grounds including:-
